Title: 75K Leak Test of October 2014

75K Leak Test of October 2014

J.C. Del Signore

11-14-2014

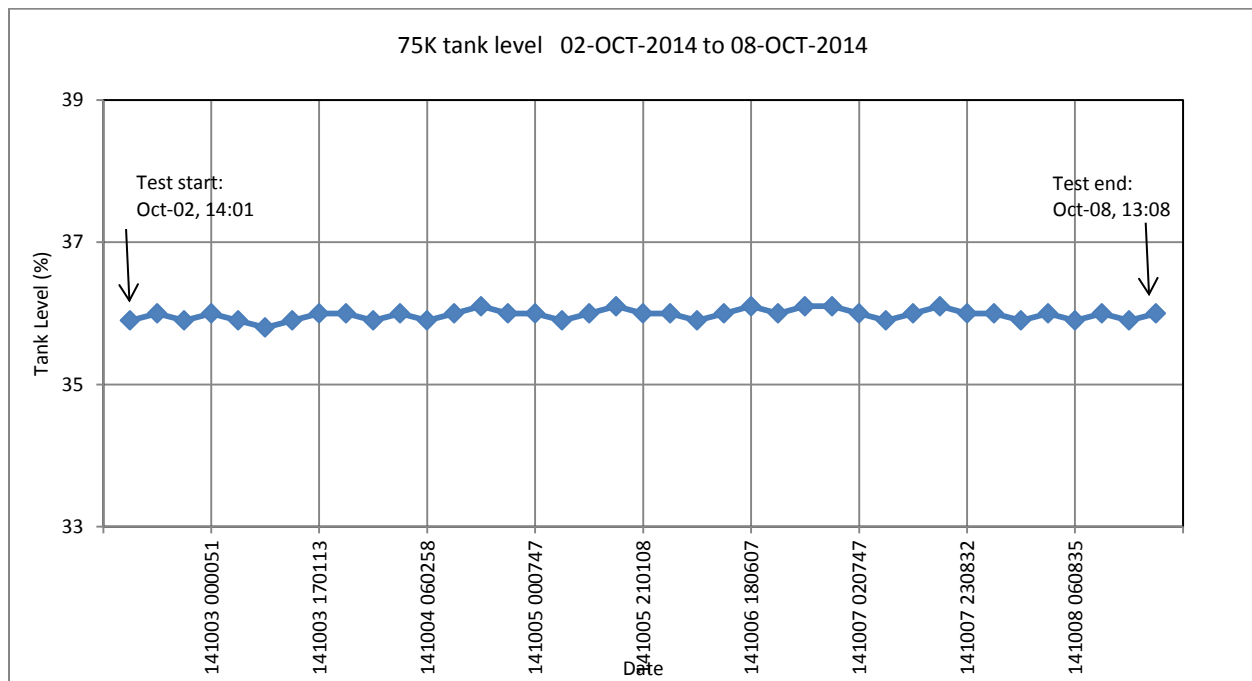
Figure 1
75K Tank Leak Test Results

Test results are summarized in Table 2 and Figure 1. Starting water level was 35.9%, and ending level was 36.0%, within level probe sensitivity. With the exception of one data point, volume of the 75K tank measured 36.0 ± 0.1 percent for the six-day, 143-hour test. Clearly, the 75K influent tank is leak-free at levels below 36%.
